HLH/ATC ENGINE SHAFT SUPPORT BEARING
DEVELOPMENT PROGRAM

Boeing Vertol Company

May 1974

4. TITLE (and Subtitle) HLH/ATC ENGINE SHAFT SUPPORT BEARING DEVELOPMENT PROGRAM		5. TYPE OF REPORT & PERIOD COVERED Final Test Results and Technology Development

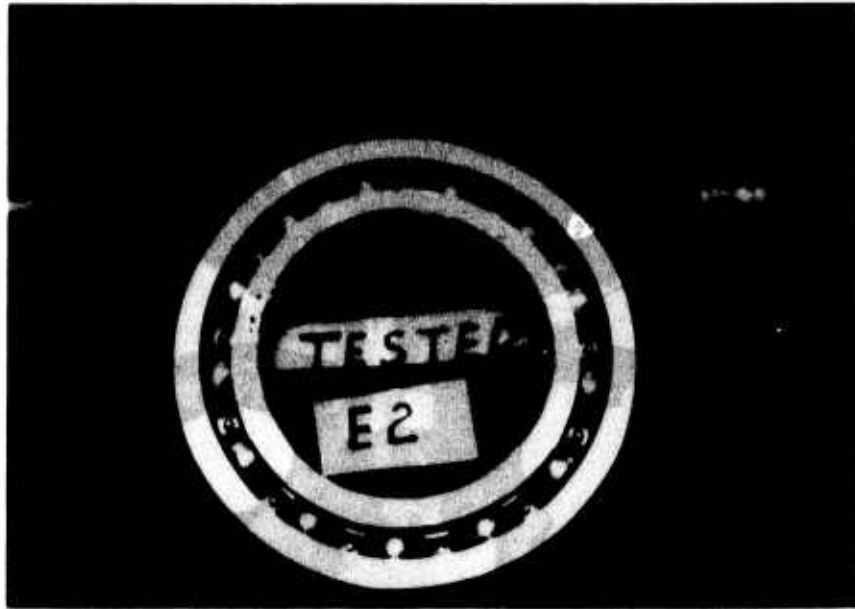
Figure 43. Bearing S/N E2, After Test 1.

This test evaluated bearings S/N E9 and E2 with standard pressed steel cages and the grease circulating device in a housing (Figure 42a) versus a standard bearing housing (Figure 42b). Each housing was packed with 7 ounces of grease. After 71.7 hours, temperature of the drive-end bearing indicated inadequate lubrication. Six ounces of grease were added to the drive-end housing and 3 ounces to the outboard. At 171.7 hours, 6 more ounces of grease were added to the drive-end housing. The test was suspended as scheduled at 300 hours. Both bearings were serviceable, but bearing S/N E9, the drive-end bearing, indicated three overheated ball pockets. See Figures 43 and 44 for examples of the bearings with standard pressed steel cages after test. Figure 45 shows the inside of both housings after test. The housing with the grease circulating device appeared to retain the grease better than the standard housing.

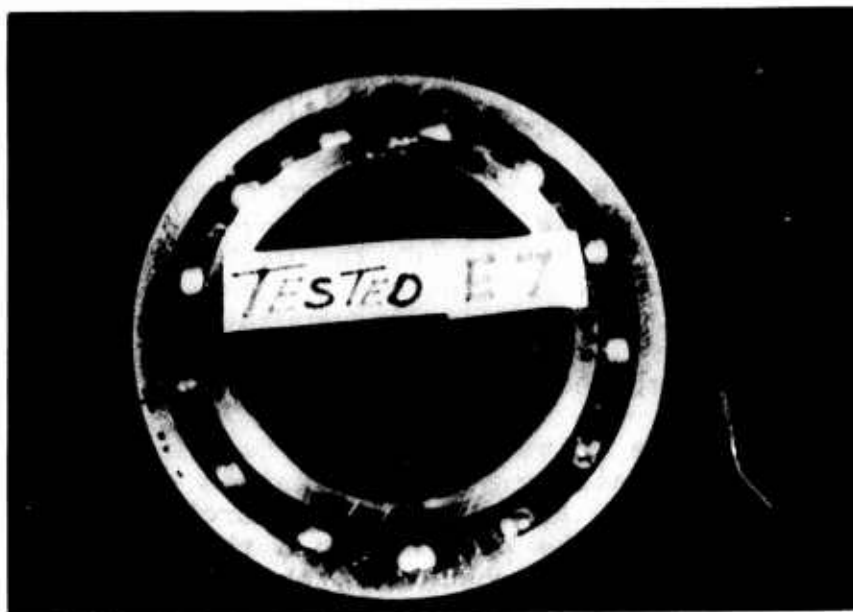
Figure 64. Standard Bearing After Test 11.

Both bearings ran 300 hours without regreasing. After 100 hours, the drive-end bearing ran somewhat hot (200°-230°F) most of the time, indicating significant cage rubbing.

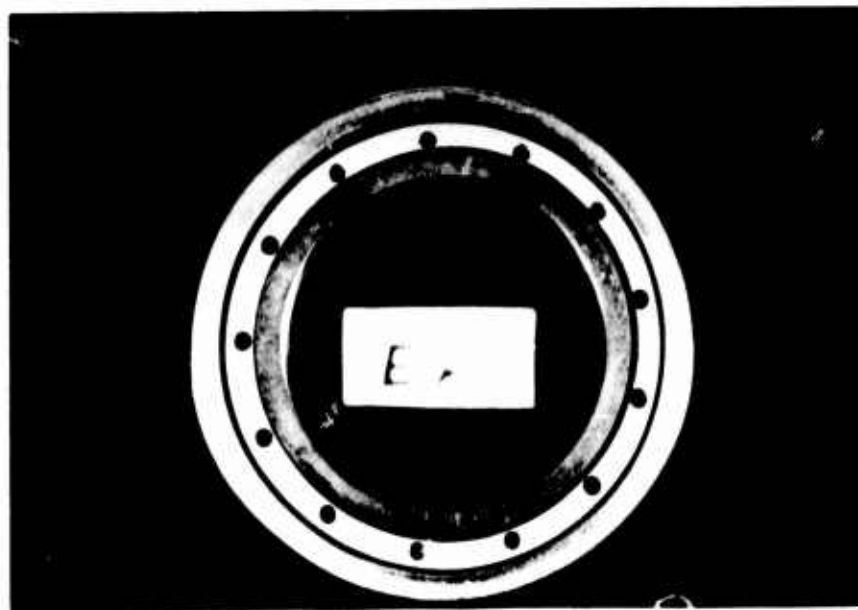
Figure 71. Bearing E6 After Test.

Figure 71 shows the outboard bearing after test. This bearing

ran with considerable vibration throughout the test, but generally ran at 200°F or below. (Prior to each regreasing, however, it reached 295°-300°F.) It required regreasing with 3 ounces per time at 70, 135.8, and 225.1 hours. At shutdown the housing was nearly empty. The cage had worn in one area to a maximum depth of 0.021 inch. At a point 180° away from the area of greatest wear, the O.D. of the cage had rubbed the outer lands but had not penetrated the silver. Balls had worn through the silver plate in the pockets. No more than a trace of Teflon was left in the surface finish of the inner lands.

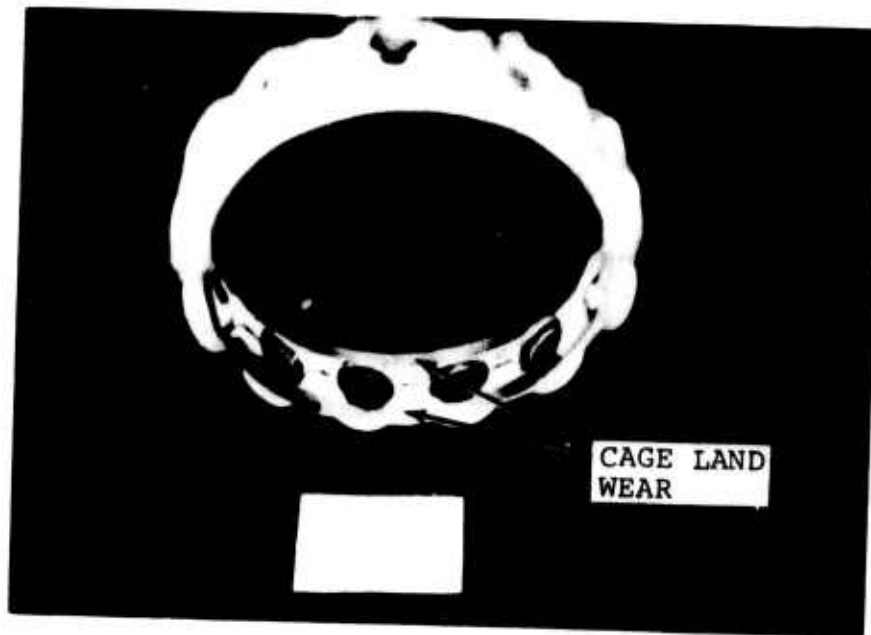
Figure 75. Cage S/N 32 After Test.

were functioning normally. Cage wear was essentially the same on both halves, again indicating an improvement.

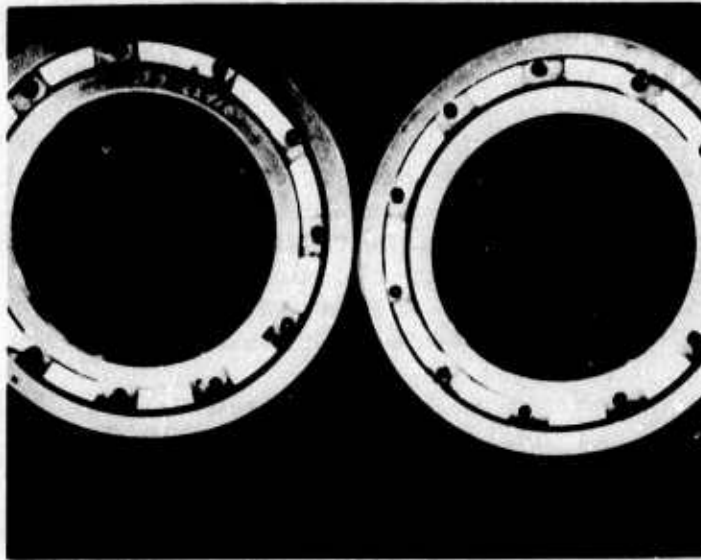
Figure 79. Bearings S/N 4 and 5 After Test (S/N 4 on Left Showed Some Cage Wear).

The damage to bearing S/N 4 did not constitute a bearing failure. It appears that wear became regenerative with particles being trapped in adjacent grease and tending to further abrade the bearing. While the housing had a great surplus of grease, the grease tended to stratify. Periodic regreasing, which would cause old grease to purge and flush the bearing, would probably have been helpful.

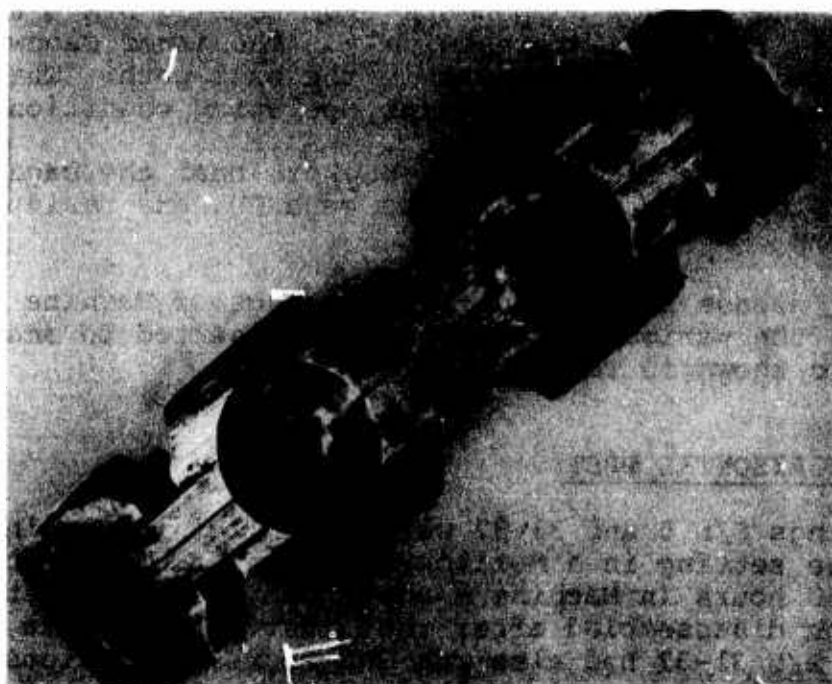
Figure 87. View of Cage O.D., Bearing S/N 6.

Figure 87 shows wear on the OD of the cage. The depth of wear is very close to the thickness of the silver plate (maximum .002 inch), with streaks of silver showing through the areas of heaviest erosion. Two partially removed rivets are also shown.

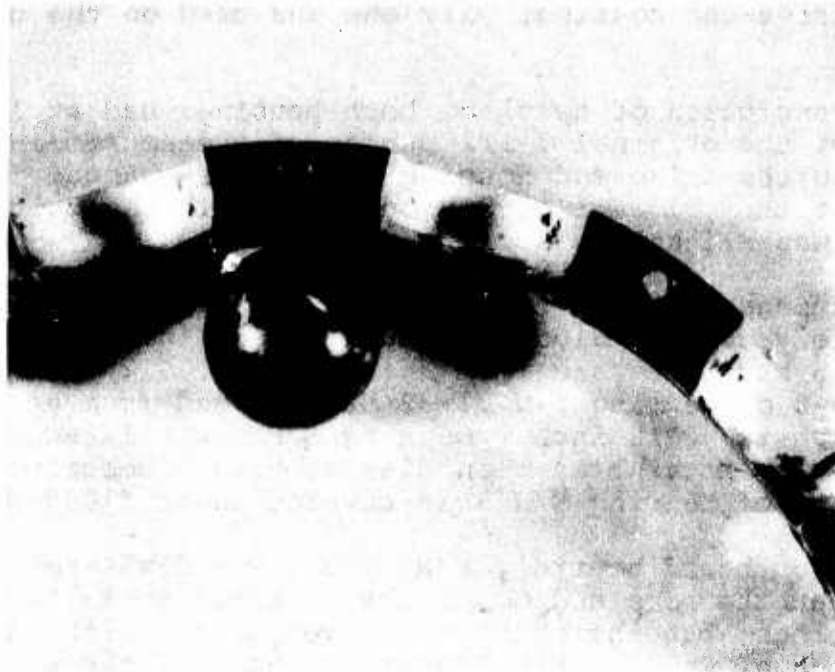
Figure 90. View of Cage Pockets and a Ball,
Bearing S/N 31-32.

Figure 90 shows a section of cage and a ball from bearing S/N 31-32. Pocket wear is concentrated near the cage bore. Small black spots at the bore in some pockets indicate chipping of material. Dark areas in the pockets toward the OD of the cage are films of residual grease.
